Building Number:	614
Area:	West Barracks
Date of Construction:	1904
Period of Significance:	1900-1919 (per HSR Part One)
Historic Use:	Hospital
Current/Recent Use:	Offices
Occupancy:	I-1.2 then B
Hazard Level:	Not Available
Number of Floors:	Three stories
Basement Floor:	7,026 sq. ft. (per January 2000 SERA report)
First Floor:	8,082 sq. ft. (per January 2000 SERA report)
Second Floor:	8,082 sq. ft. (per January 2000 SERA report)
Third Floor:	6,064 sq. ft. (per January 2000 SERA report)
Exterior Materials:	Painted red brick, wood tongue and groove at porches, wood shingle siding at dormers.

Task One: Conditions Assessment

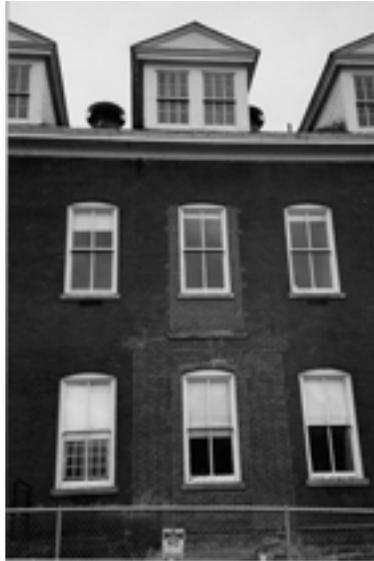
The west elevation of the hospital shows the location of the walkways to the Annex building.

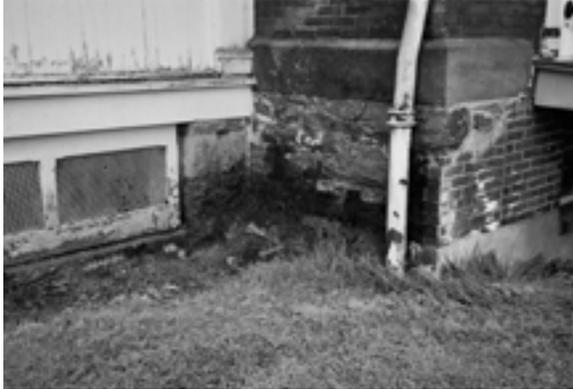
The south porch where it meets the relocated Annex shows a lot of damage.
